Elwha River Fisheries and Ecosystem Restoration

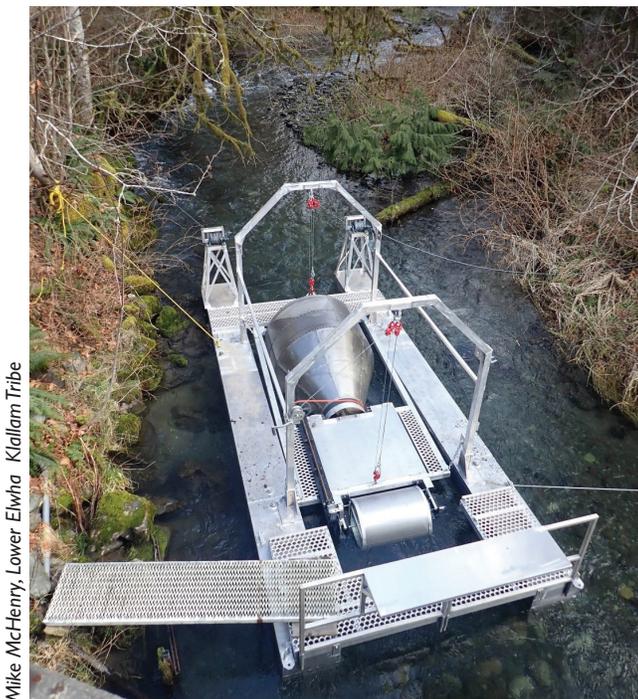
A smolt trap on Little River (one of three within the Elwha River valley).

The tribe is conducting long-term population level monitoring of the response of salmon to dam removal. These efforts were initiated in the mid-2000s and the tribe is using a fish in-fish out model to monitor populations before, during and after dam removal. This life history approach requires enumeration of returning adults, juvenile abundance and smolt out-migrants.

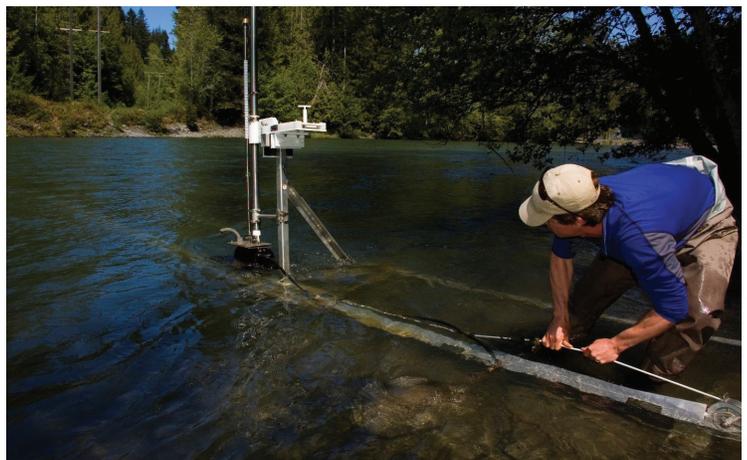
Setting up SONAR camera for enumeration of adults.

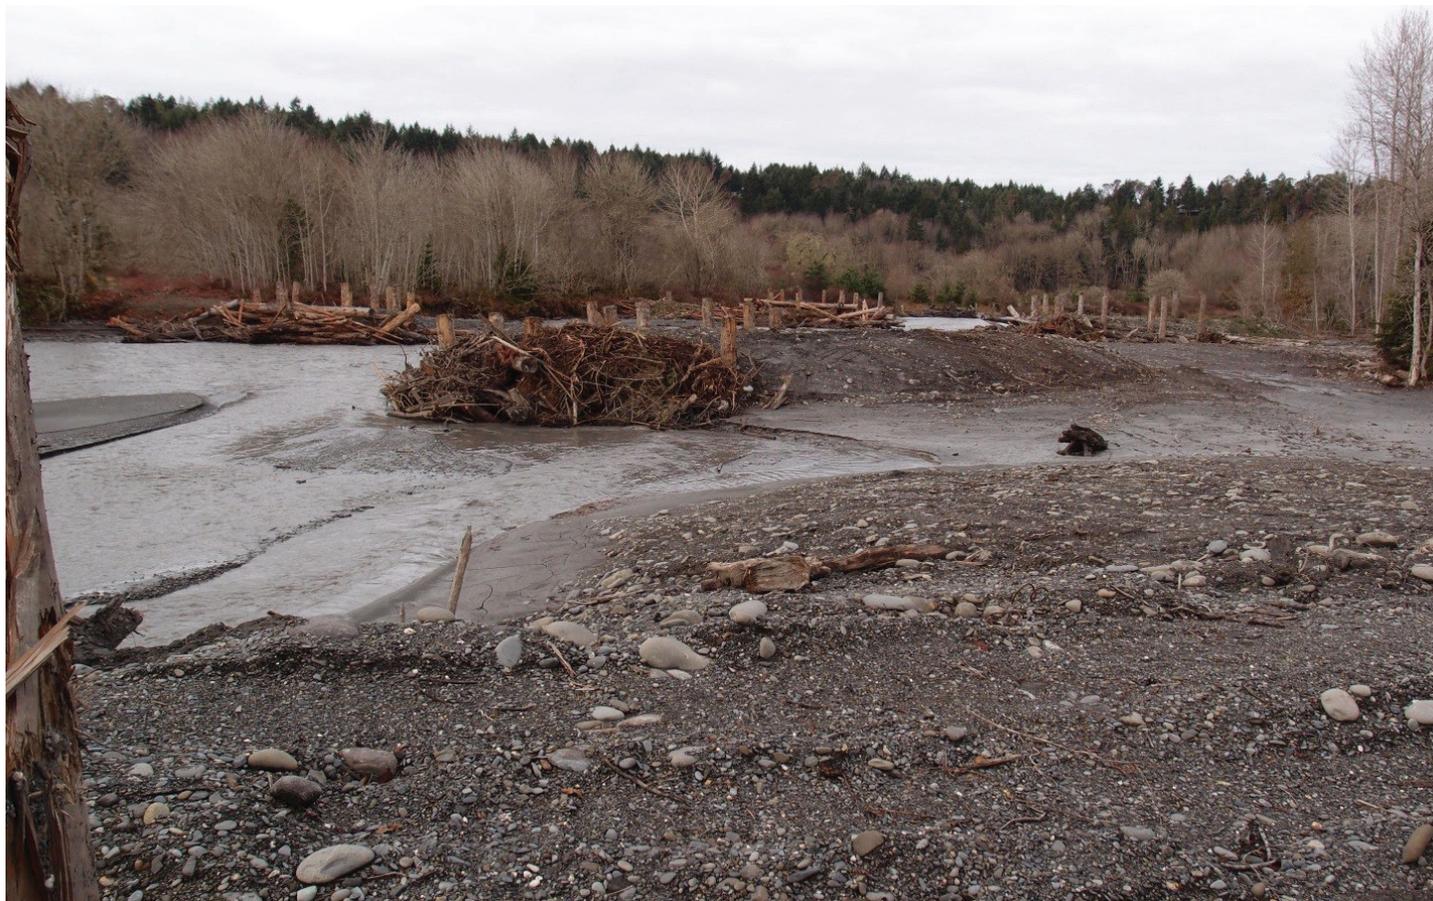
Newly constructed engineered logjams in the lower Elwha River. The structures are designed to split flows, activate new side channels, create pools and sort gravel.

The restoration strategy involved four tools: 1) the removal of abandoned flood control dikes in the floodplain, 2) the insertion of engineered logjams in the mainstem, 3) addition of free wood in side-channels and 4) floodplain revegetation. Over time and with increasing experience conducting restoration in a large river, the project grew in scale and complexity. While initial restoration actions were focused on simply providing salmon with a refuge while awaiting the possibility of dam removal, later restoration efforts focused on design that would be com-

In 2014, both dams had been removed and the Elwha was restored to a free flowing river. A 15-year lower river floodplain restoration effort had resulted in the construction of 50 engineered logjams, the removal of four floodplain dikes, three side channels loaded with large wood, and the planting of 400,000 native trees and shrubs.
